QUIET CLEAN SHORT-HAUL EXPERIMENTAL ENGINE (OCSEE)
UNDER-THE-WING (UWU)
ENGINE COMPOSITE NACELLE TEST REPORT

Volume I - Summary, Aerodynamic and Mechanical Performance

APRIL 1979

Advanced Engineering and Technology Programs Department
Aircraft Engine Engineering Division

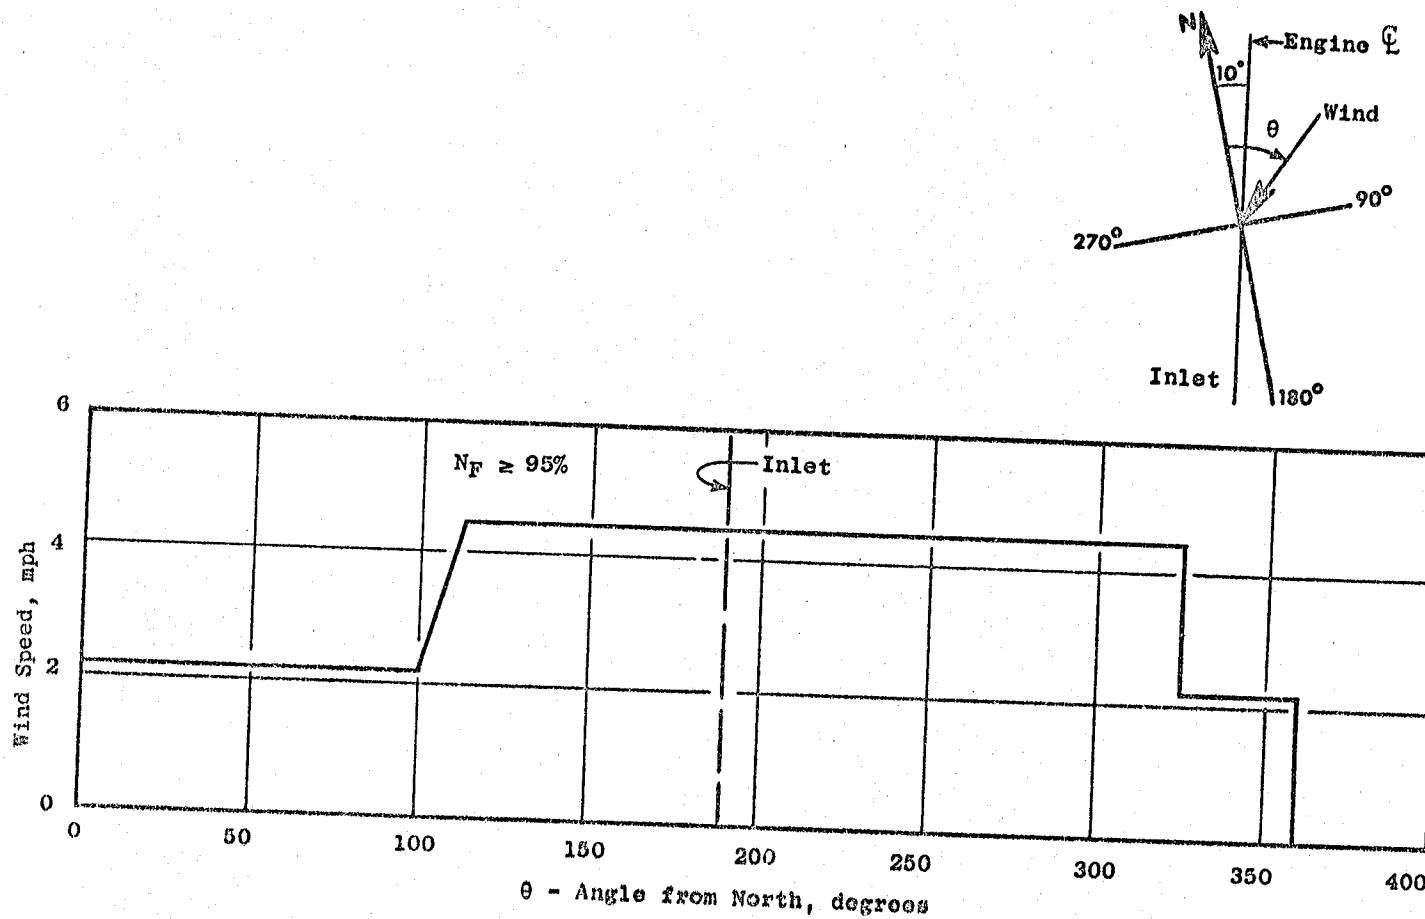
Figure 30. QCSEE UTW Blade Stress Wind Limits.

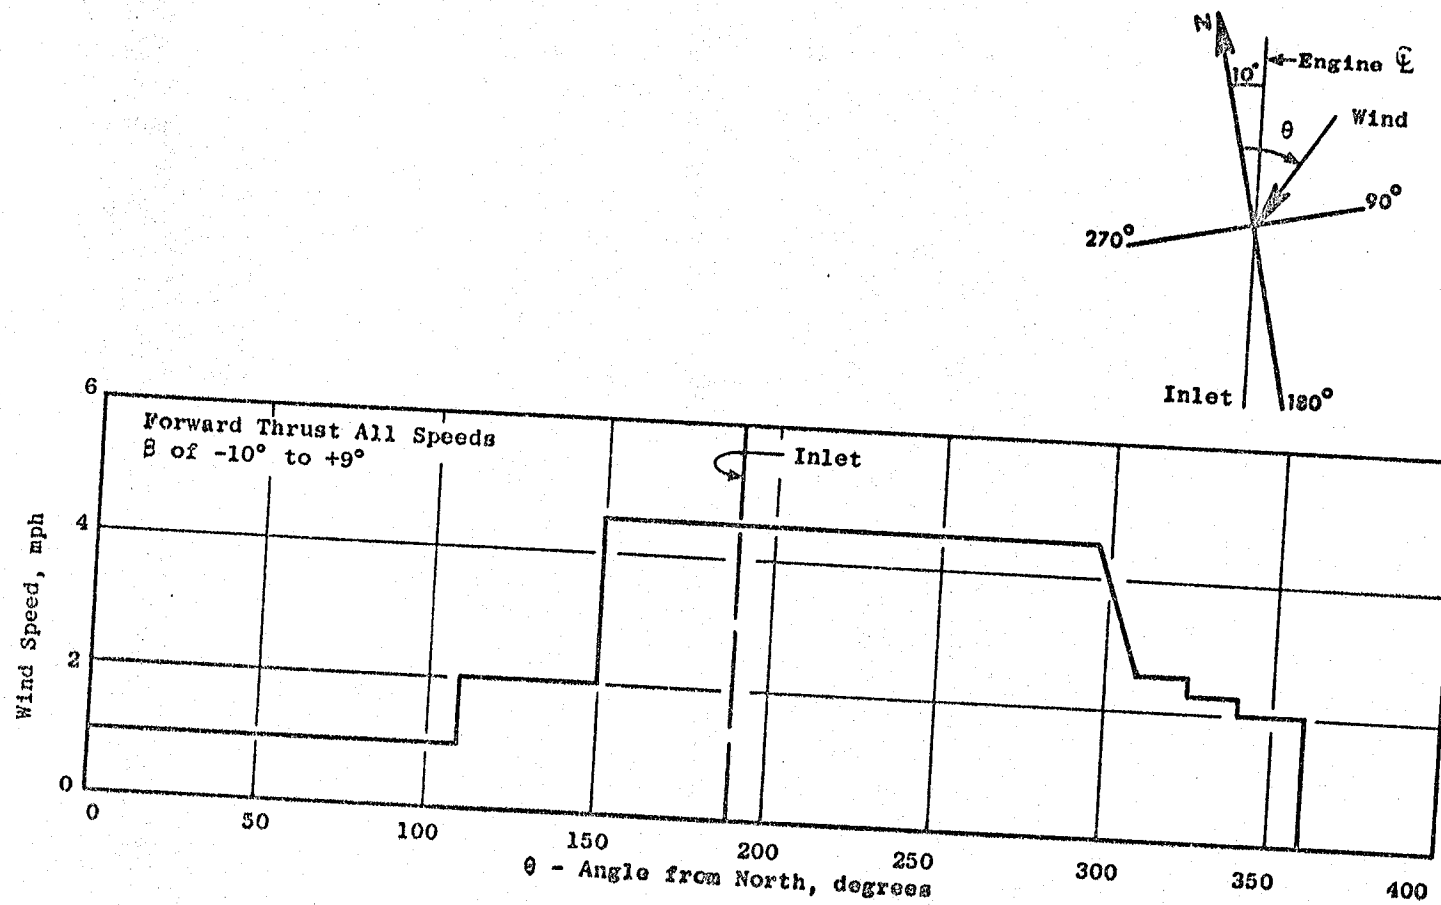
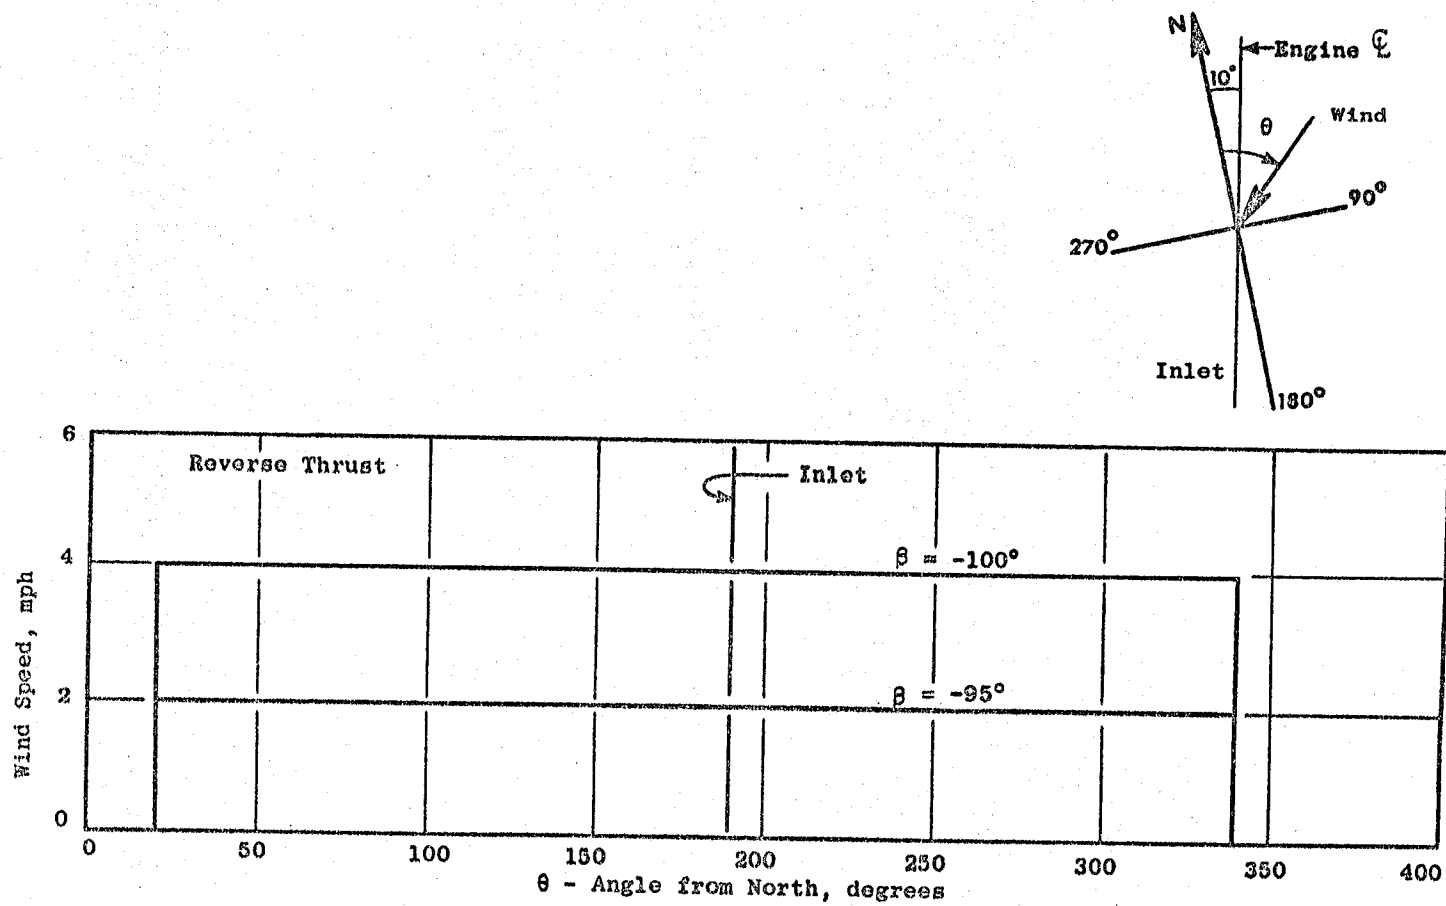
Figure 31. QCSEE UTW Wind Effects on Blade Stresses.

Figure 32. QCSEE UTW Wind Effects on Blade Stresses.

Figure 33. QCSEE UTW Wind Effects on Blade Stresses.

- Blade vibratory response is extremely sensitive to wind/inlet distortion conditions.
- Tailwinds (possibly with some reingestion or inlet lip separation) seem to be the worst wind condition.

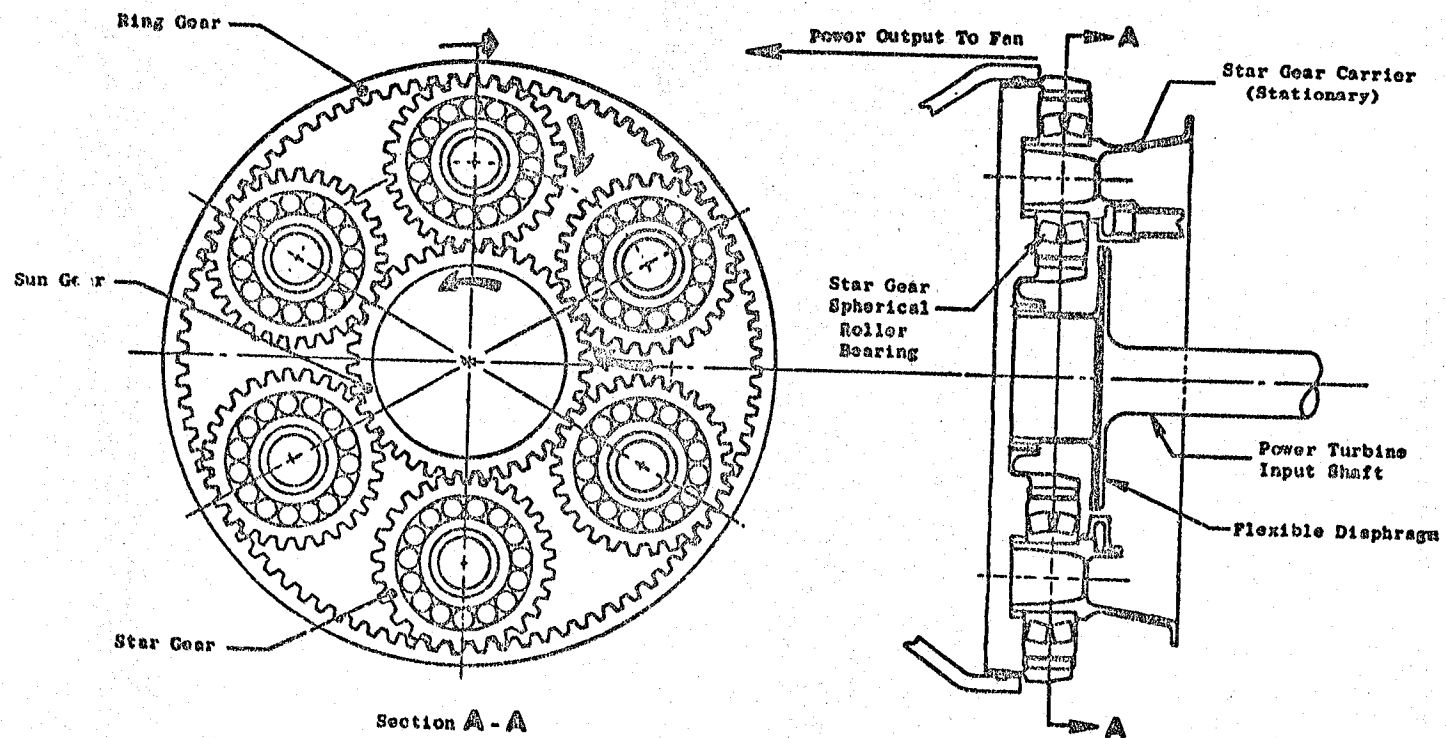
Figure 34. Main Reduction Gear Configuration.

The UTW engine has a star-type epicyclic reduction gearset located in the forward engine sump to reduce the low-pressure turbine speed to fan rotor speed. The gearset is shown schematically in Figure 34. The gearset consists of a flexibly mounted sun gear, which drives six star gears, which are mounted on a fixed carrier and which drive a ring gear. The ring gear is flexibly mounted to the fan shaft. Principle design characteristics of the gears are listed in Table XXII.

During testing of the UTW engine, the main reduction gear operated without problems. As in previous testing, ring gear strain gages indicated vibratory stress well within allowable limits. Maximum bearing temperature did not exceed the 403 K (265° F) limit. Engine heat rejection data reported in Section 12.0 of this report, was 31.16×10^4 J/sec (17,708 Btu/sec) at takeoff speed. Although the contribution of the main reduction gear to the total heat rejection cannot be accurately determined, the gear efficiency appeared to be 1 to 2 percent below the design objective value of 99.2 percent.

The engine was not disassembled at the conclusion of testing however, the variable pitch mechanism was removed on March 11, 1978 and the main reduction gear was exposed. The gear tooth patterns indicated normal uniform wear across the tooth faces. Total engine running time on the gear at that time was 106:13 hours.

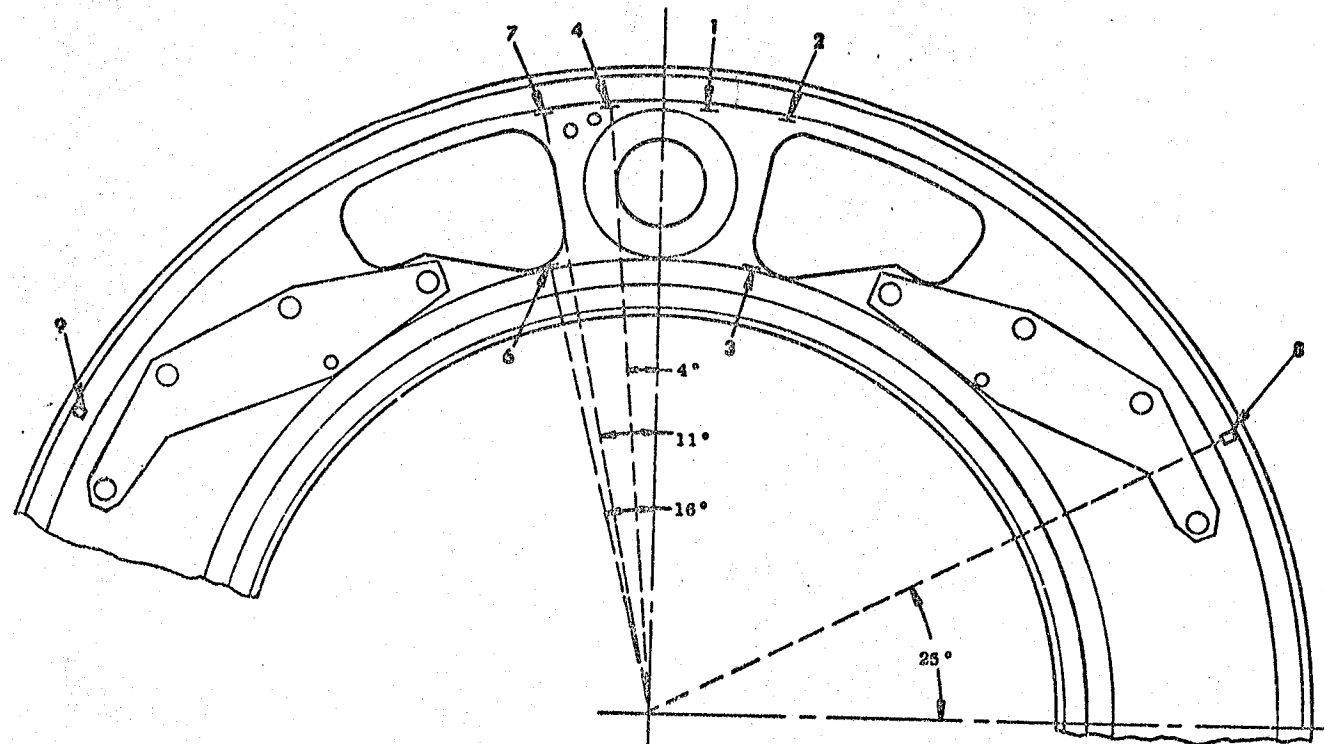
Figure 42. Strain Gage Locations for UTW Fan Frame, Mount Area.

During the second build of the UTW, the frame was instrumented with a total of six strain gages. Three of these were located in the engine mount area as shown in Figure 42. The other three gages were located on the fan bypass vanes as shown in Figure 43.

None of the gages in the mount area showed any significant response during engine operation. This was expected since normal operating loads are quite low compared to the five blade-out loads for which the structure was designed. The highest stress observed during engine test was only 2 percent of the ultimate strength of the material. Stresses that low cannot be detected on the engine monitor scopes.

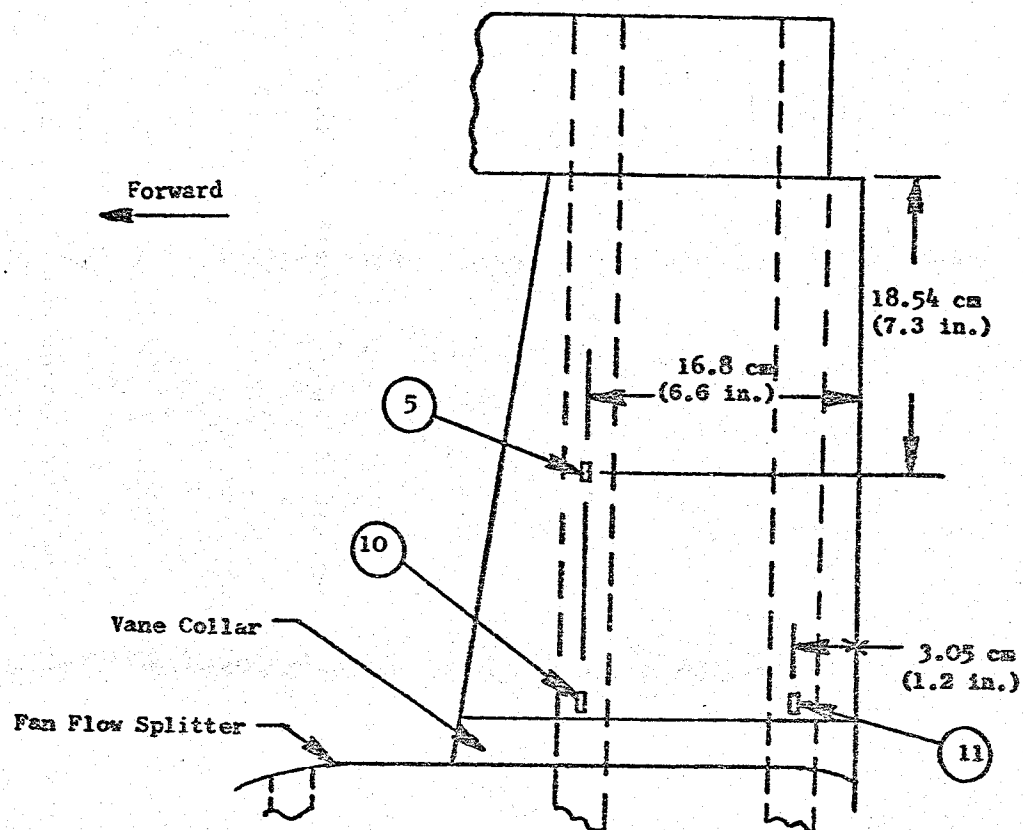
Figure 43. Strain Gage Locations for UTW Fan Frame, Bypass Vanes.

The only frame gages showing any activity during engine operation were the working gages on the bypass vanes. All observed stresses on these vanes were low, less than 4 percent of the ultimate strength of the material at the worst case of 95 percent fan speed, an A18 of 1.87 m² (2900 in.²), and a blade angle of -5°. These stresses were caused by a 2/rev forced input. The stresses became less as A18 was decreased and/or the blade angle moved from negative angles toward positive angles.

It was possible, by increasing the scope sensitivity, to detect the vane natural frequencies (first flex only) as they were excited by a fan 18/rev. These frequencies were lower than expected based on bench testing of a single vane. It is probably that the actual end fixity of the vanes is somewhat less than it was for the bench test specimen which had its ends cast in Devcon (a filled epoxy). The bench test results are shown in Figure 44 along with the natural frequency data obtained during engine running. The "open-2" expected values shown in Figure 44 were analytically extrapolated from the "closed-2" bench test data. Stresses increased momentarily as the fan speed passed through these frequencies but never exceeded 4 percent of the ultimate strength capability.

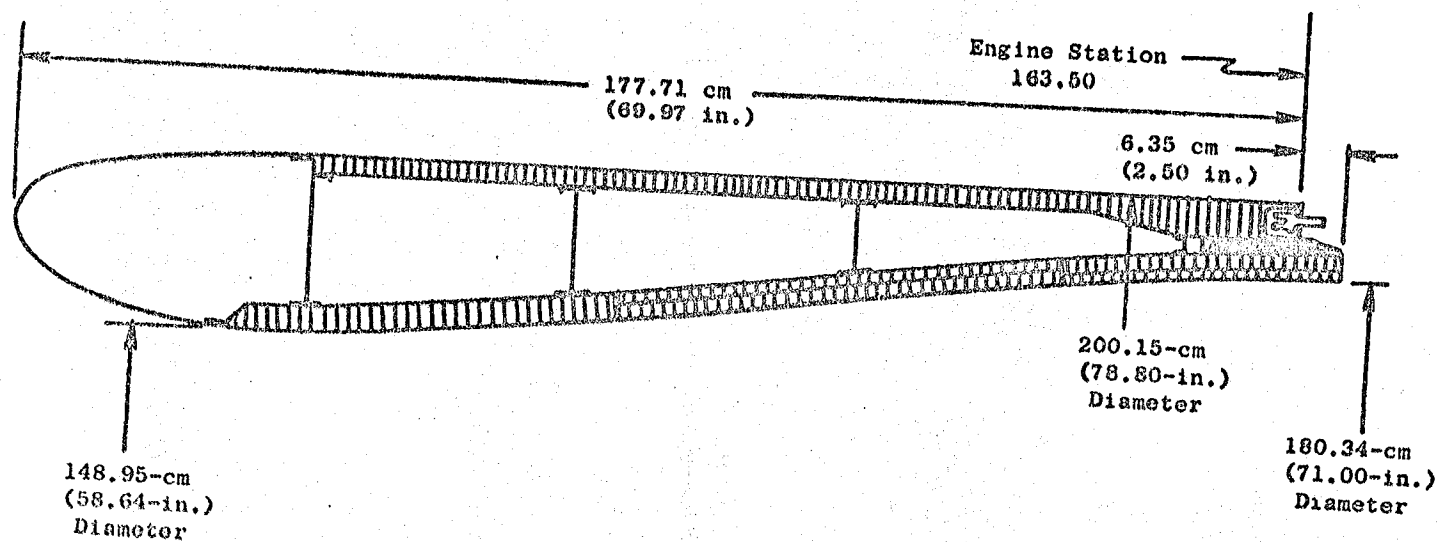
Figure 46. QCSEE Inlet Axial Cross Section.

The composite inlet is a honeycomb sandwich structure with Kevlar 49/epoxy face sheets and aluminum core. Mounting to the fan frame is provided by means of quick disconnect rotary latches. The overall length is 184.07 cm (72.47 inches) and the outside diameter is 200.15 cm (78.8 inches). A cross section through the inlet is shown in Figure 46.

When the inlet was first mounted on the fan frame, it was discovered that the inner flowpath at the fan frame interface was under size by approximately 0.635 cm (0.25 inch) on the radius. This was corrected by filling the last 15.24 cm (6.0 inches) of the inlet honeycomb with microballoon filled epoxy, machining a straight taper from the existing contour to the correct exit diameter, and covering this repair with a 4 ply, 181 fiberglass/epoxy lamination. This resulted in the loss of approximately 0.84 square meters (9 square feet) of acoustical suppression area.

It was also discovered that there were some unbonded areas in the inner panel axial splice joints. These were repaired by injecting room temperature curine EA 901/81 epoxy adhesive into the bondline. No further problems were encountered with the inlet during testing and posttest inspection did not uncover any indications of damage or delamination.

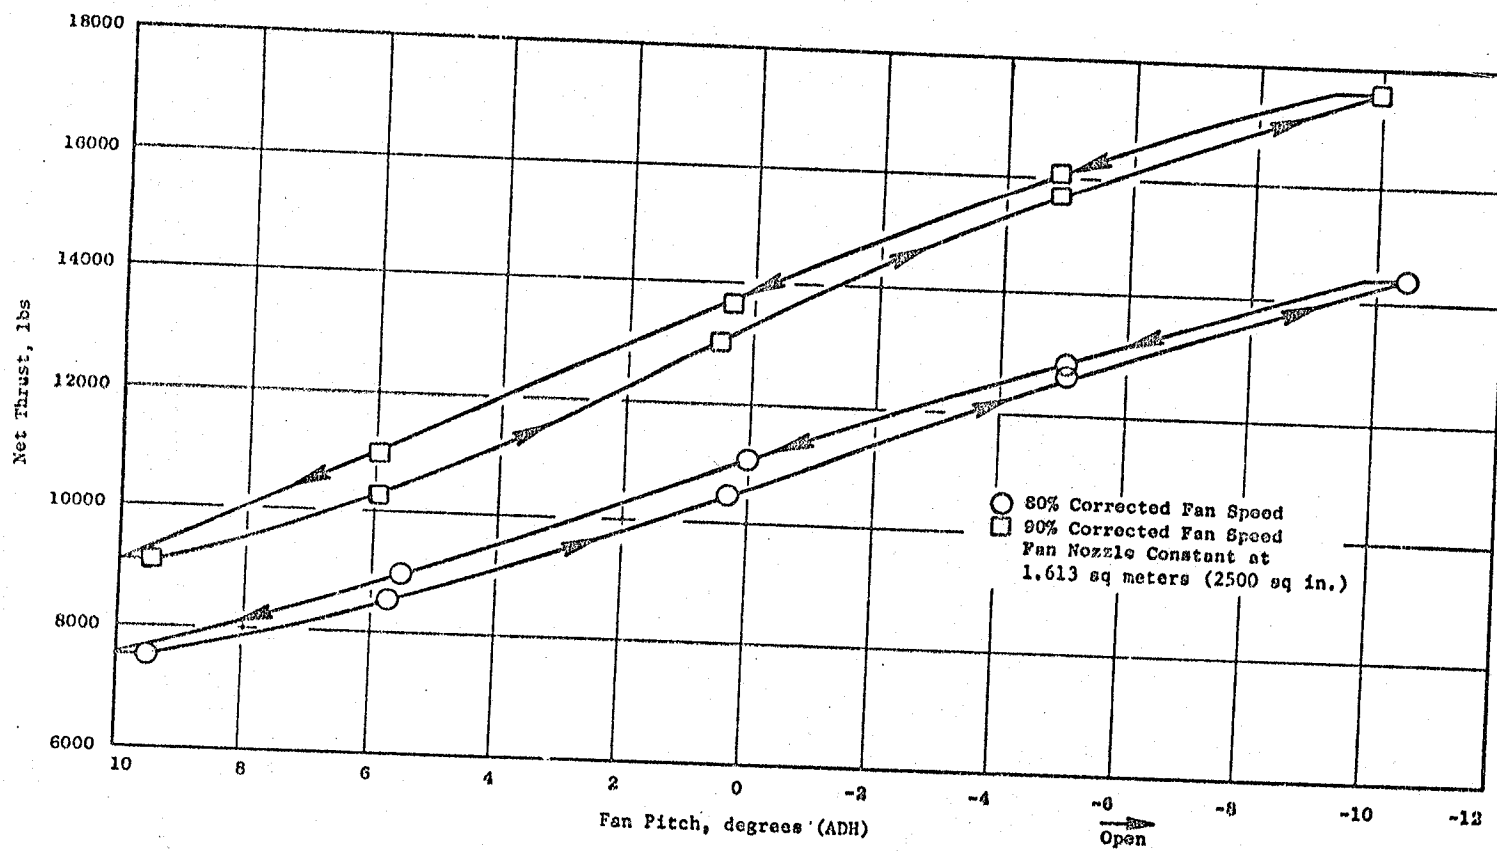
Figure 56. Fan Pitch Hysteresis Check, QCSEE UTW 507-001/2.

Data from engine testing with fan pitch manually controlled revealed hysteresis in the pitch actuation mechanism. Figure 56 shows data from a run in which fan pitch was moved in increments in both directions between $+10^\circ$ and -10° at two different fan speeds with the fan nozzle constant. At any particular thrust level, if corrected fan speed, nozzle area, and ambient conditions are constant, then actual fan pitch must also be constant. Thus the spread in indicated pitch (measured at the input to the actuation mechanism) at constant thrust and corrected speed on Figure 56 indicates hysteresis in the actuation mechanism between the position transducers and the fan blades. To compensate for this, pitch settings were approached from the closed direction and calibration data were taken in the same way. The source of the hysteresis has not been identified.
